## Smart Meter Fires & Stab Connections

## Smart Meter Fires & Wired Connections

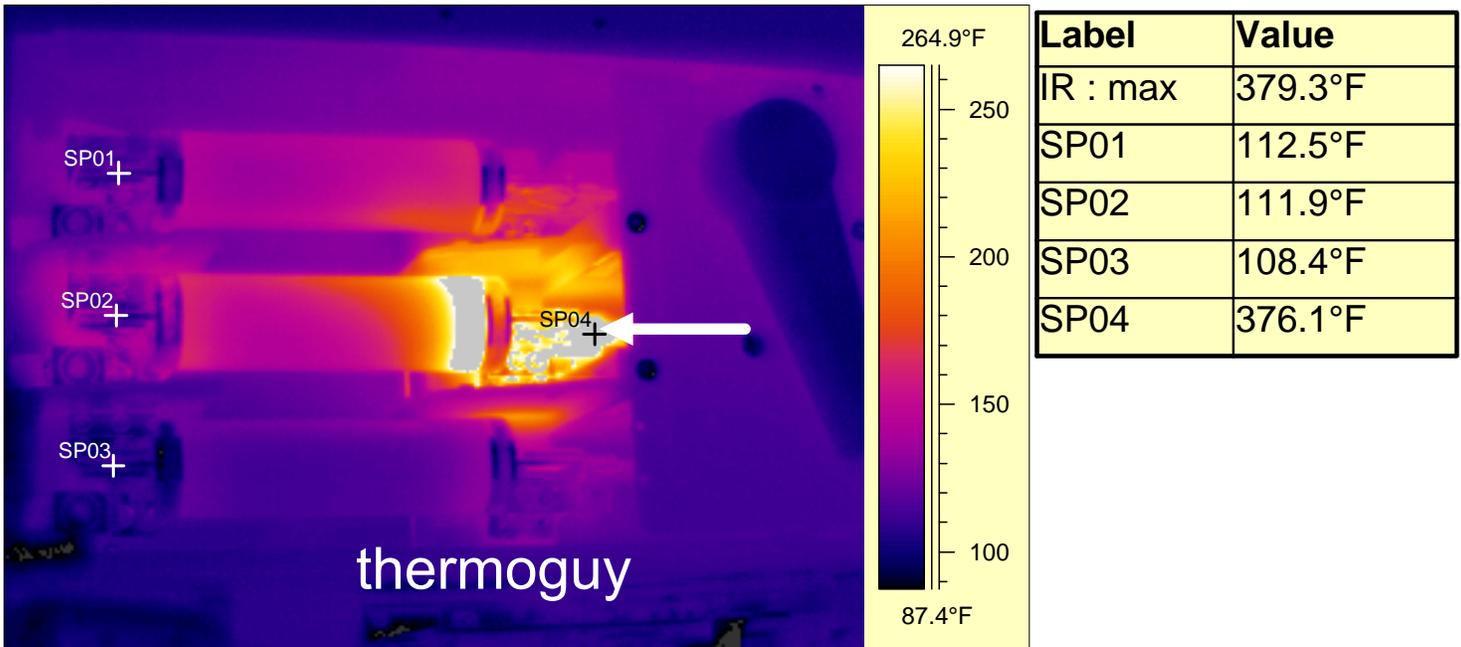
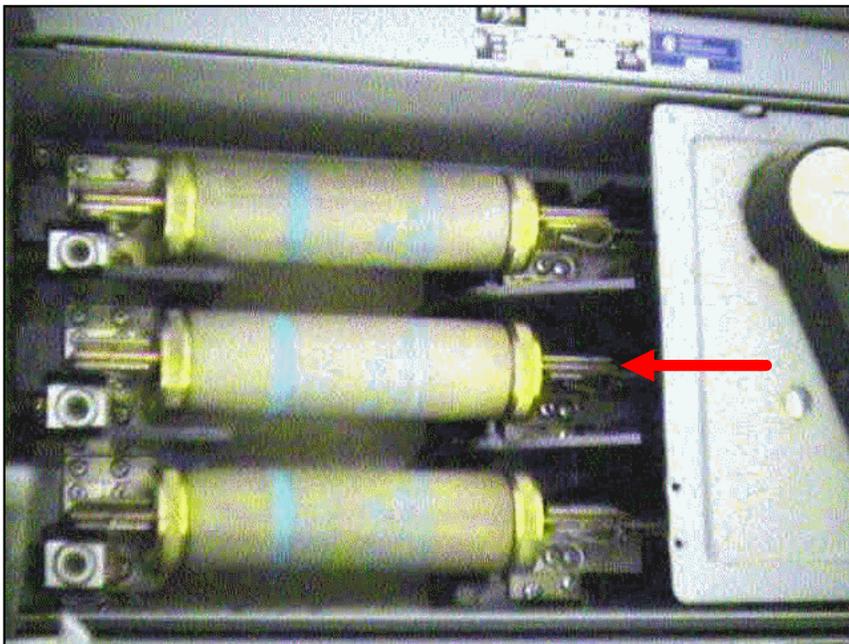
The fused disconnect above highlights stab connection failure and to educate people that meter bases as well as the existing meter have stab connections that have never been maintained. Note the connection at the arrow is 265 deg. F warmer than the other connections. More electrical load will accelerate the chance for failure or fire.

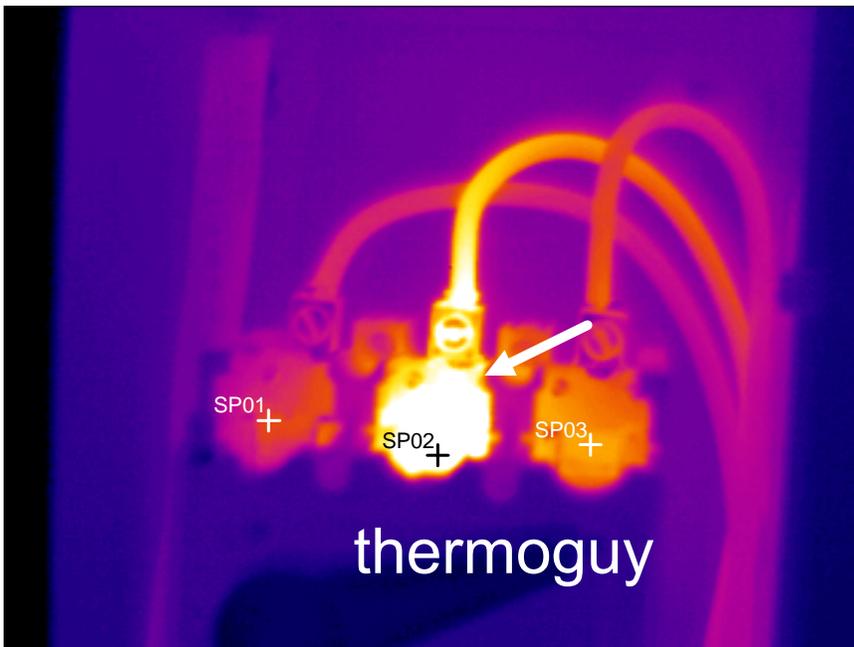
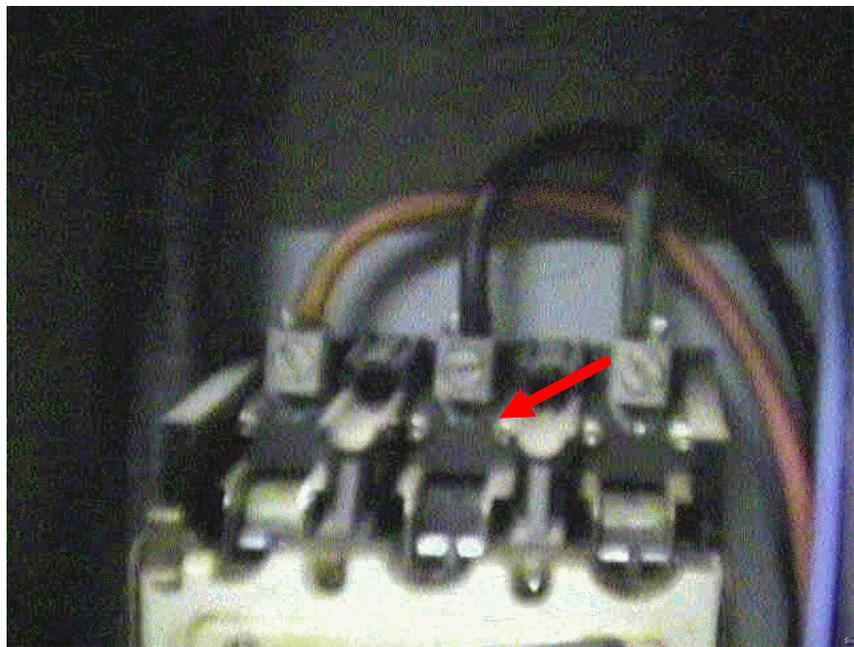
IR information	Value
Date of creation	4/23/2001
Time of creation	1:35:39 PM
Label	Value
IR : max	313.7°F
IR : min	88.4°F
SP01	169.6°F
SP02	313.7°F
SP03	202.5°F

In the electrical example above, a faulty wired connection welded in a closed position so they couldn't turn the switch off. It required changing the disconnect live or there would have been electrical failure resulting in explosion, fire or both.

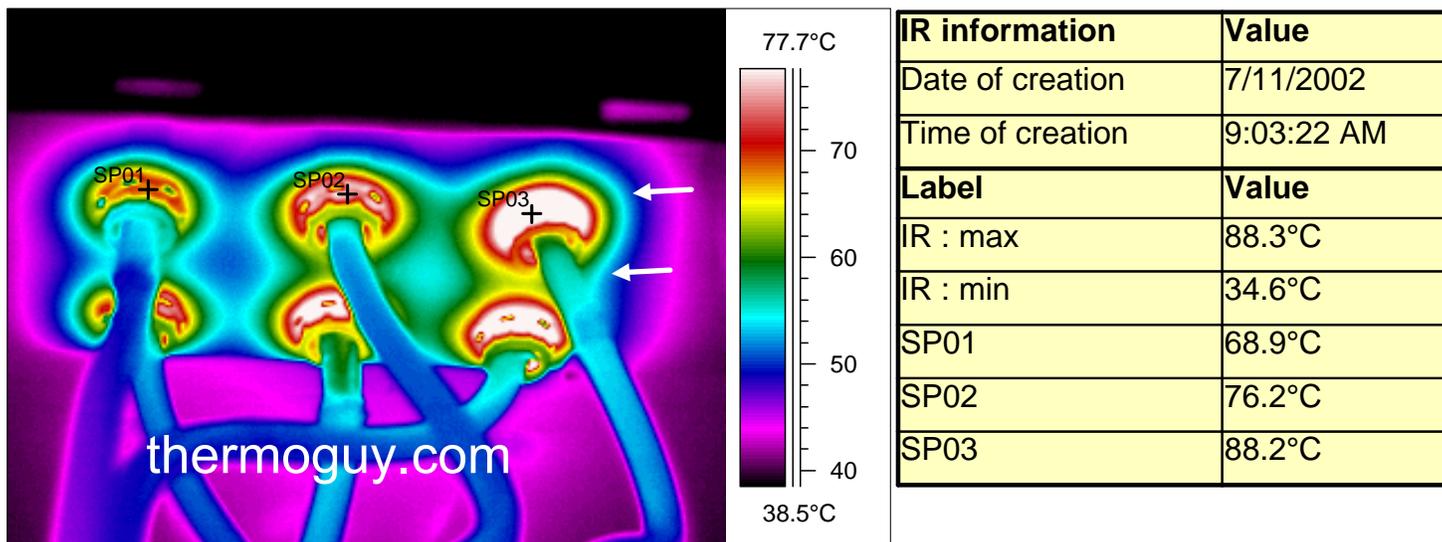
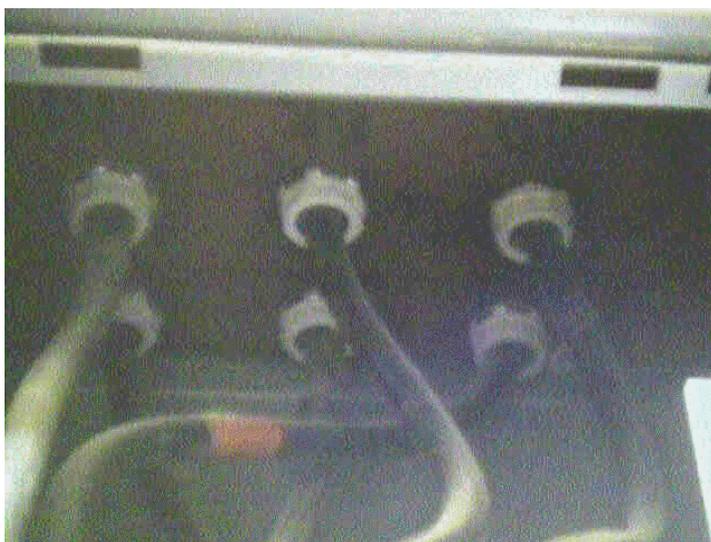
The IR image above are called parallel feeds, big wires feeding a Motor Control Centre in a lumber mill. Electrical professionals accommodate the EMFs around **each** conductor using a non magnetizing insulating board. This installation didn't use the Mica board so the 60 Hz EMFs induce currents and cause the molecules of affected metal cabinet to change direction at twice the frequency. Metal doesn't change direction easily and heat is a byproduct. The wire insulation is rated for 90 deg. C. and close to being exceeded. Breakdown in insulation would result in a groundfault and violent explosion. This is with extremely low frequencies.
