## Smart Meter Fires & Stab Connections

## Smart Meter Fires & Wired Connections

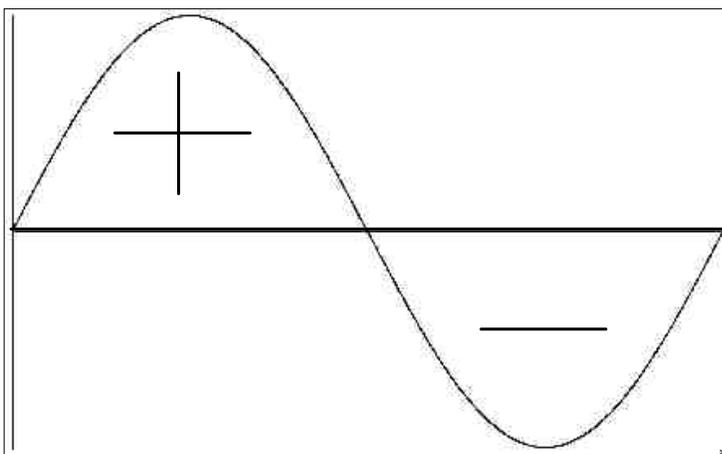
1 cycle of a 60 Hz Frequency

### Example of Extremely Low Frequency (60 Hz) Causing Electrical Failure

The IR image above are called parallel feeds, big wires feeding a Motor Control Centre in a lumber mill. Electrical professionals accommodate the EMFs around **each** conductor using a non magnetizing insulating board. This installation didn't use the Mica board so the 60 Hz EMFs induce currents and cause the molecules of affected metal cabinet to change direction at twice the frequency. Metal doesn't change direction easily and heat is a byproduct. The wire insulation is rated for 90 deg. C. and close to being exceeded. Breakdown in insulation would result in a groundfault and violent explosion. This is with extremely low frequencies.
